REBEL[®] Concrete Sensor Test Results Overview for Road & Bridge

Summer 2023 – Fall 2024

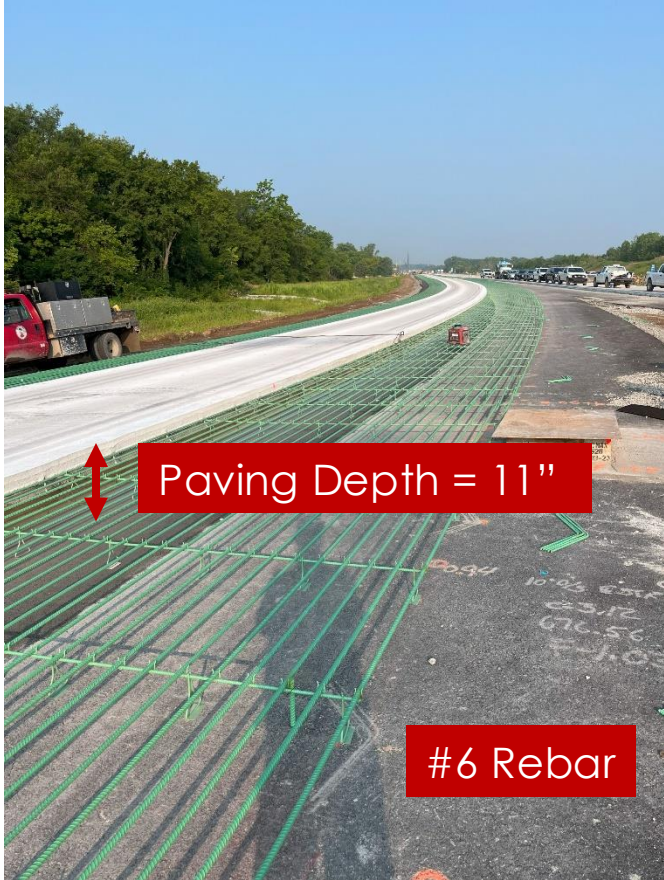
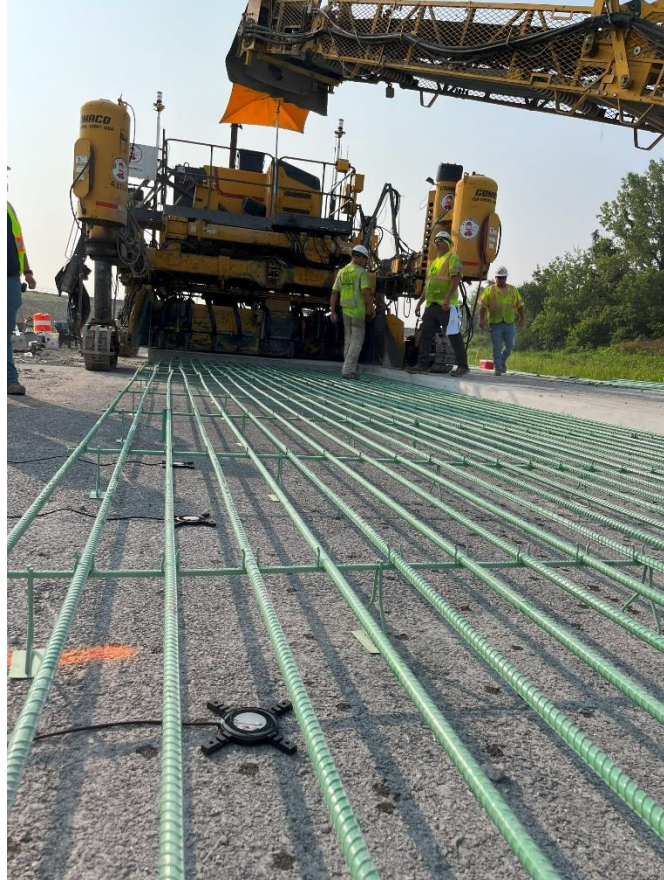
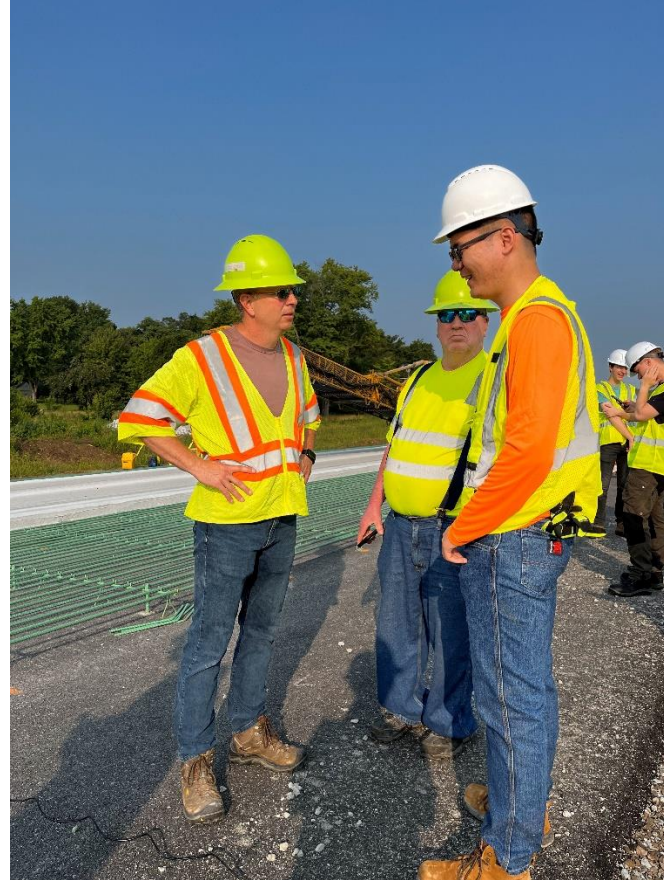
- 2 sensors placed in the pavement and 1 in a companion beam taken to the lab
- Cylinders were measured at 1, 3, 7, and 28 days
- Core was taken at 7-days
- Pavement sensors were within ACI allowable variability of 15% across all ages beyond 7 days

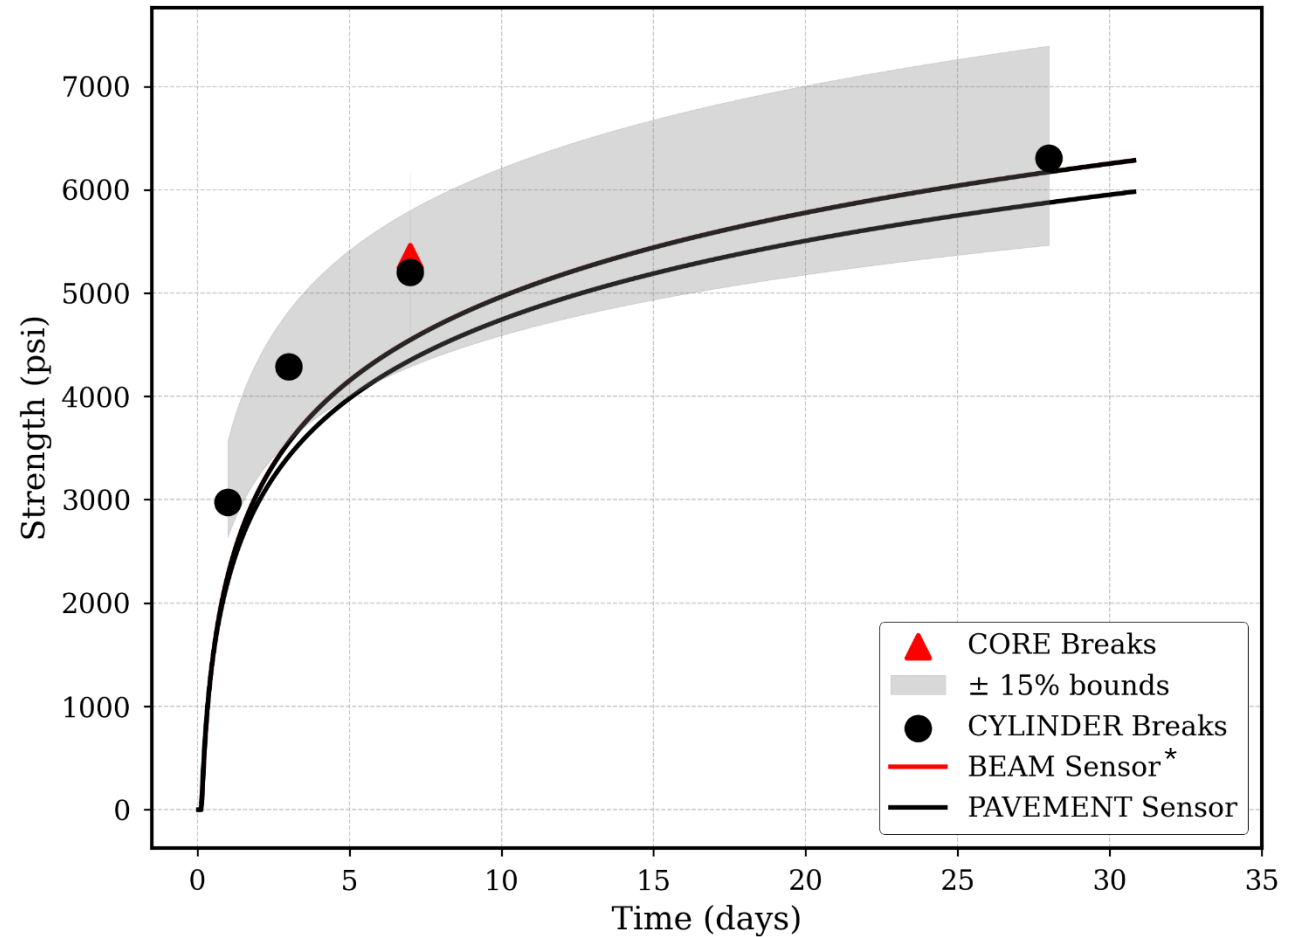
* Red BEAM Sensor Line Overlapped with Top PAVEMENT Sensor Line

- REBEL Sensor measurements were within 15% of cylinders at 7-day and 28-day
- Sensor measurements were within ~16% of cores at 7-days
- Sensor variability was excellent, with <2.5% variation in measurements across sensors at all ages

7-Day Strength	Avg. Strength	Difference from Core (%)
Core	5355	--
Cylinders	5044	5.8
REBEL Sensor	4481	16.3

Age	Avg. Difference Cylinders vs Sensors (psi)	Avg. Difference Cylinders vs Sensors (%)
1-Day	730	24.3
3-Day	778	18.5
7-Day	721	13.8
28-Day	233	3.6

Age	Sensor Variability (%)
1-Day	1.2
3-Day	1.8
7-Day	2.1
28-Day	2.3

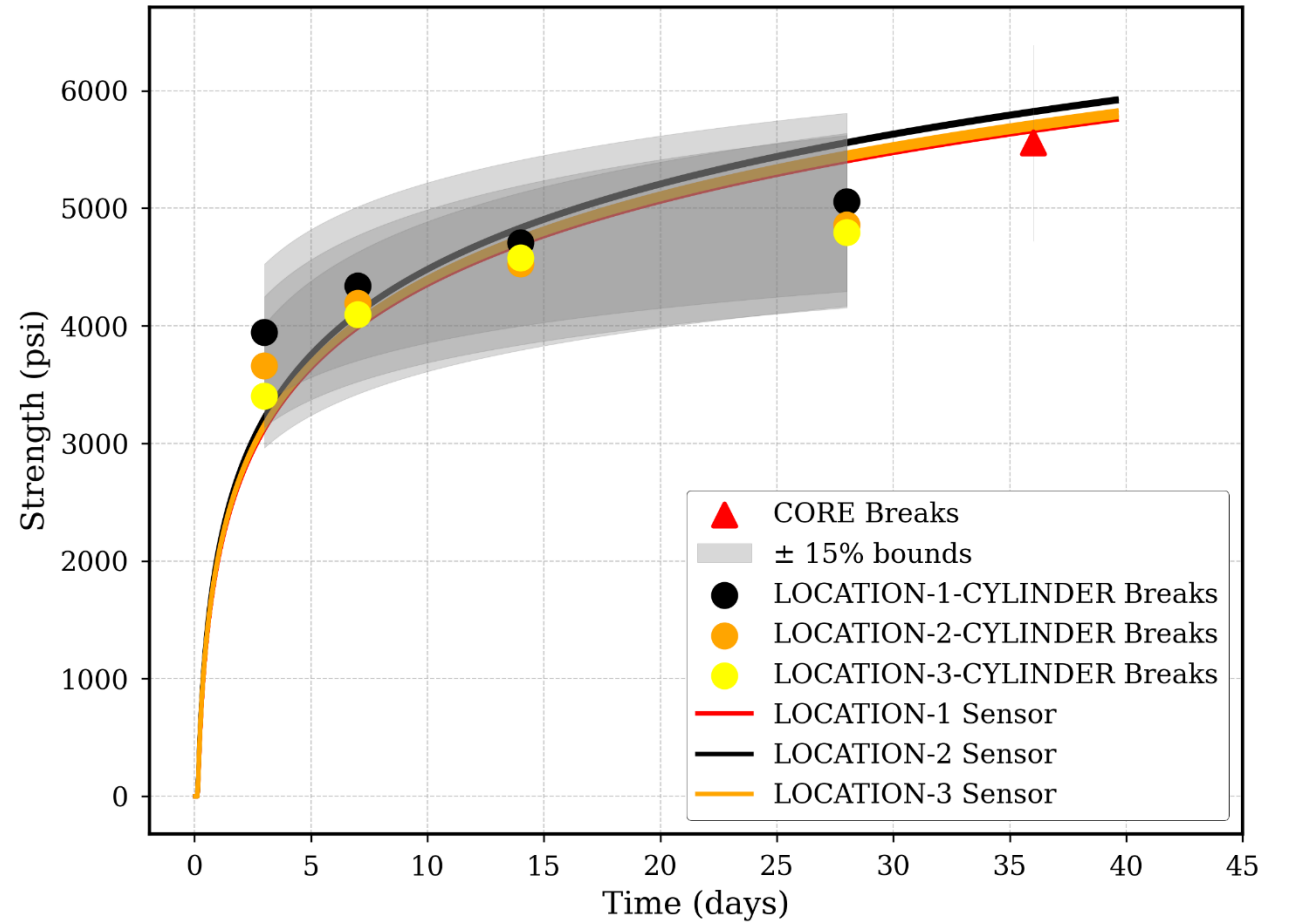
* Cylinder strength extrapolated from curve fit

- REBEL Sensors were within 15% of cylinders at all ages
- REBEL Sensors were also within 3% of the 36-day core
- Sensor variability was excellent, with <6% variation in measurements across sensors at all ages

36-Day Strength	Avg. Strength	Difference from Core (%)
Core	5557	--
Cylinders*	5087	8.5
REBEL Sensor	5720	2.9

Age	Avg. Difference Cylinders vs Sensors (psi)	Avg. Difference Cylinders vs Sensors (%)
3-Day	513	13.6
7-Day	180	4.2
14-Day	98	2.1
28-Day	552	11.3

Age	Sensor Variability (%)	Cylinder Variability (%)
3-Day	1.2	6.0
7-Day	1.1	2.4
14-Day	1.1	1.6
28-Day	1.1	2.2

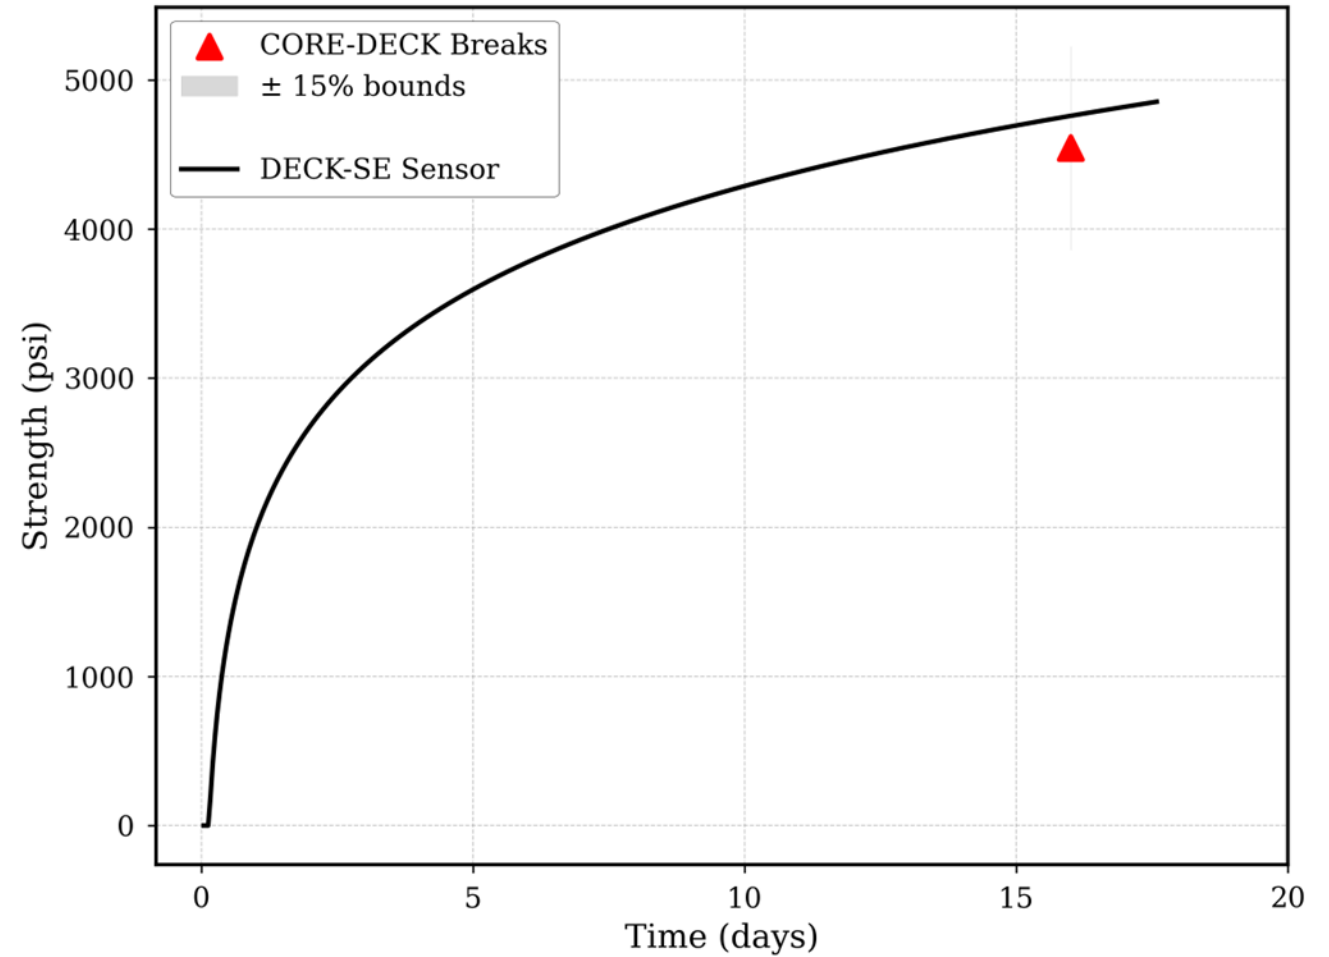
- Sensor was placed in the bridge deck, with one core taken at 16-days
- Sensor was very accurate (within 4.7% of core measurement)

Avg. Strength	Difference from Core (%)
Core	4545	--
REBEL Sensor	4760	4.7

Age	Avg. Difference (psi)	Avg. Difference (%)
16-Day	214	4.7

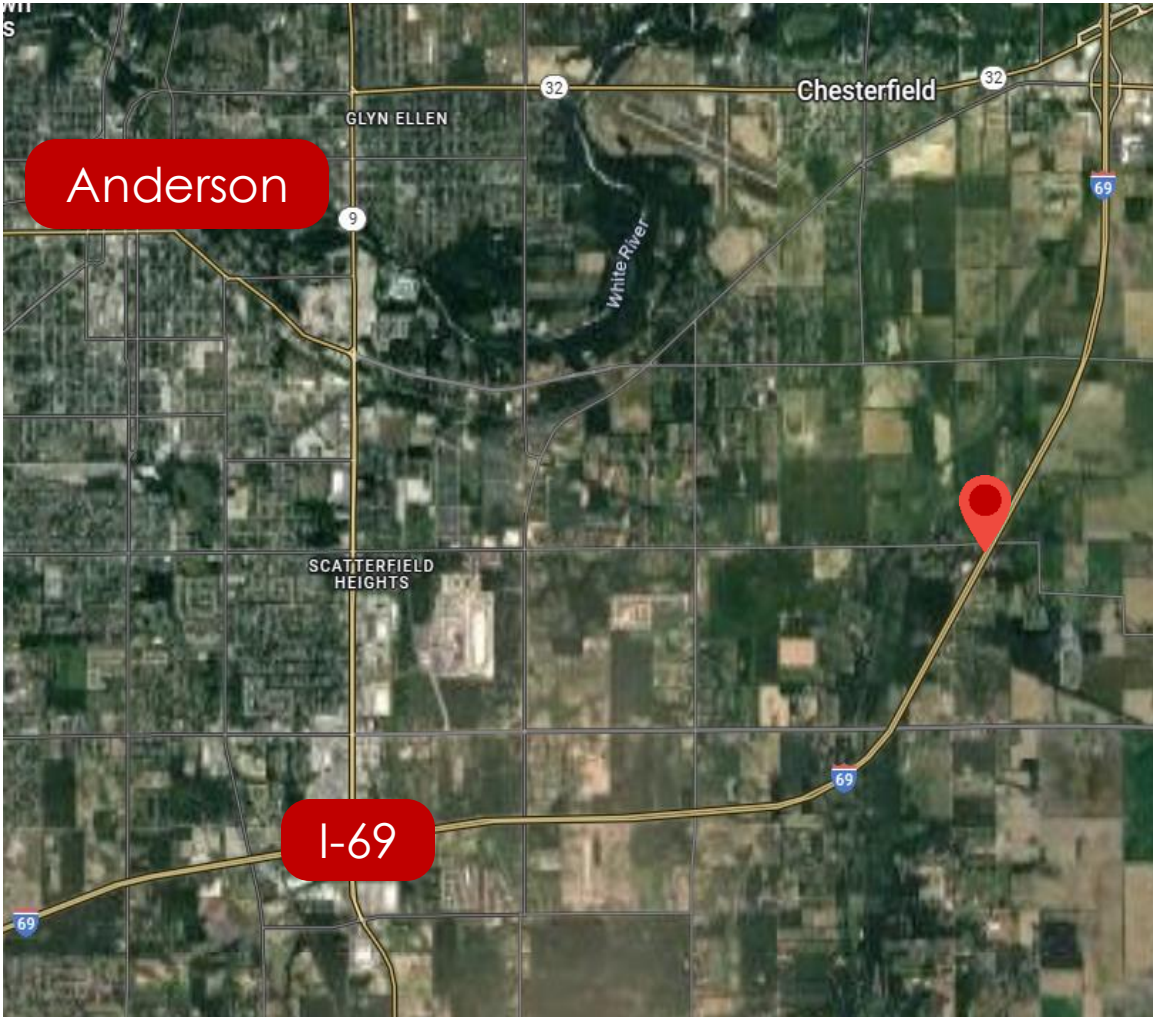
Date	6-6-2024
Location	Anderson, IN
Project Type	Bridge Deck

- 1 sensor was placed in the bridge deck with another in the approach
- Cylinders made for 1, 4, 7, 14, and 28-days
- Both sets of cylinders broke below expectations at 14 and 28 days
- Core break at 32 days confirms that the sensor results fall in line with the in-place strength

- Both sets of cylinders broke below expectations at 14 and 28 days
- The core break at 32 days confirms that the sensor results fall in line with the in-place strength

32-day	Avg. Strength	Difference from Core (%)
Core	6517	--
Cylinders*	5464	16.1
REBEL Sensor	7216	10.7

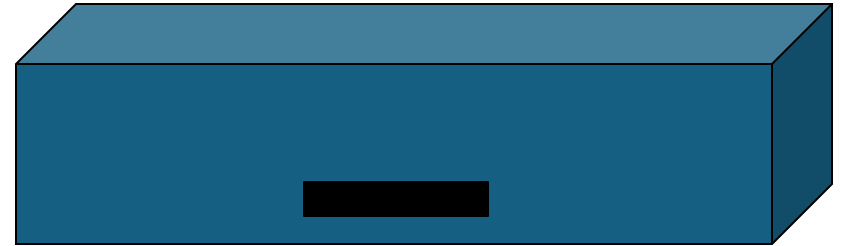
Sensors in a beam cured in the field

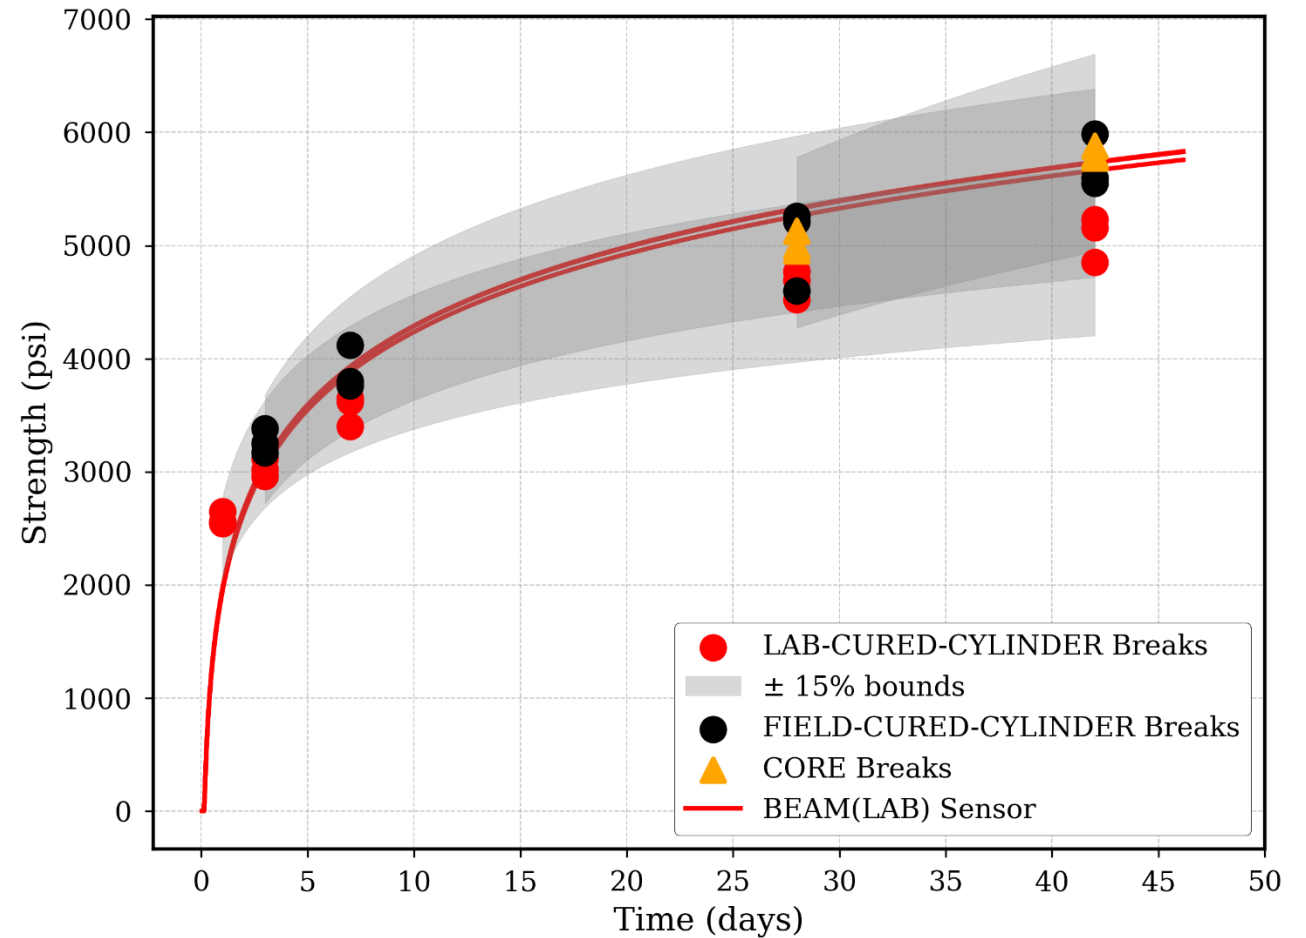
Lab-Cured Beam Sensors

- The sensors in the lab-cured beam sample reported strength close to the in-field cylinders and sensors
- 4 sets of cylinders were measured at 1, 3, 7, 28, and 42-days
- Cores were taken at 28 and 42 days

- Sensors were within 10% of cylinder measurements taken past day 3
- Variability was low across all sensors at all ages (<1%)
- Lab-cured sensors were within 5% of 28-day cores and within 2% of 42-day cores

Age	Avg. Difference (psi)	Avg. Difference (%)
1-Day	623	24.1
3-Day	200	6.1
7-Day	23	0.6
28-Day	462	9.5
42-Day	173	3.1

Age	Sensor Variability (%)	Cylinder Variability (%)
1-Day	0.5	1.9
3-Day	0.6	4.4
7-Day	0.6	6.0
28-Day	0.6	5.2
42-Day	0.6	6.5

28-day Comparison	Avg. Strength	Difference from Core (%)
Core	5027	--
Cylinders	4925	2.0
REBEL Sensor	5304	5.5

42-day Comparison	Avg. Strength	Difference from Core (%)
Core	5819	--
Cylinders	5237	10.0
REBEL Sensor	5710	1.9

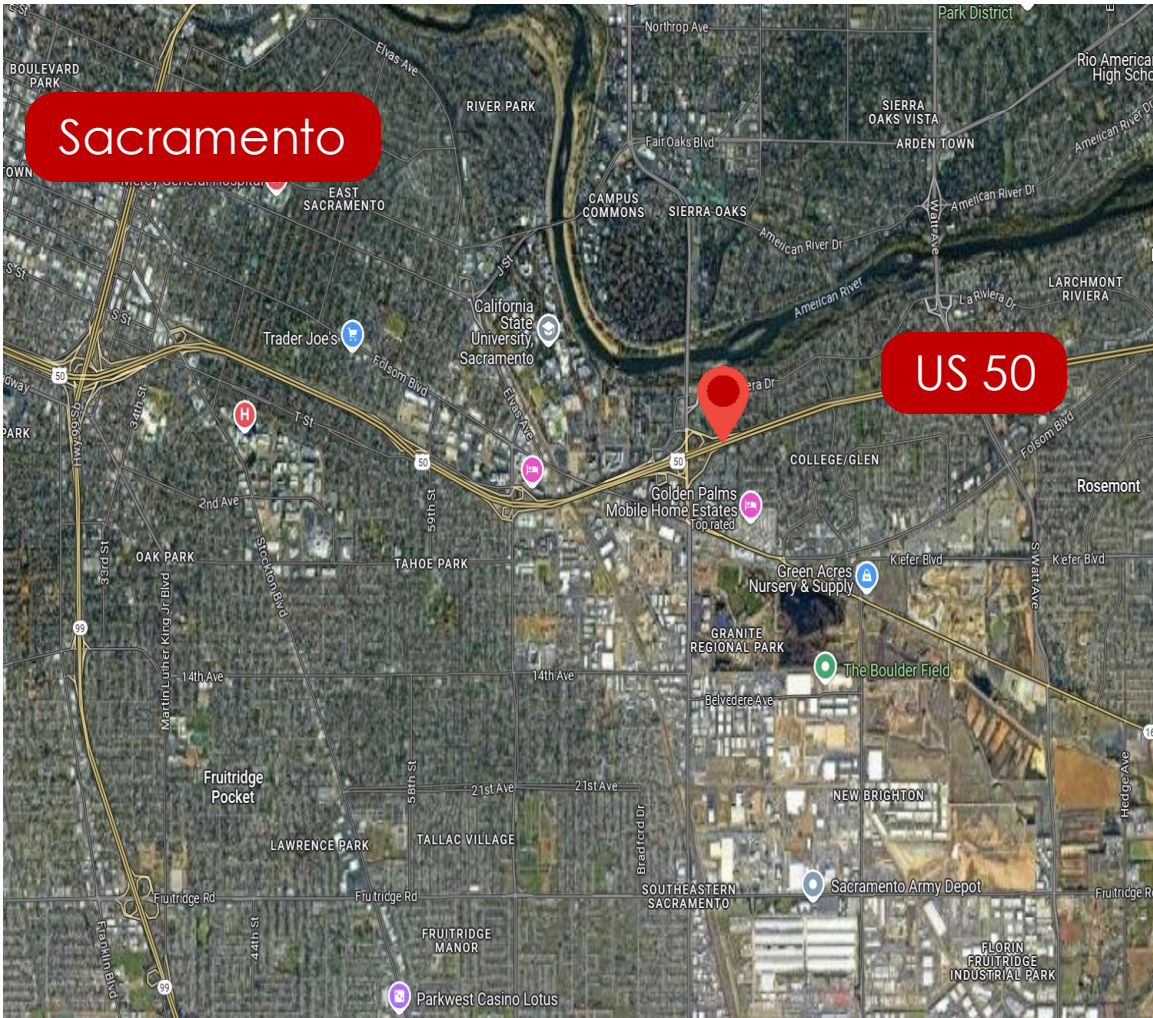
Date	9-15-2023
Location	Sacramento, CA
Pavement Thickness	14"
Rebar	6" interval, 7.5" high

- Sensors in the pavement reported similar strength as the cylinder breaks (within 15%).
- The sensors in a separate beam sample reported lower strengths, which reflects the effect of different curing conditions for in-place structure vs separate sample.

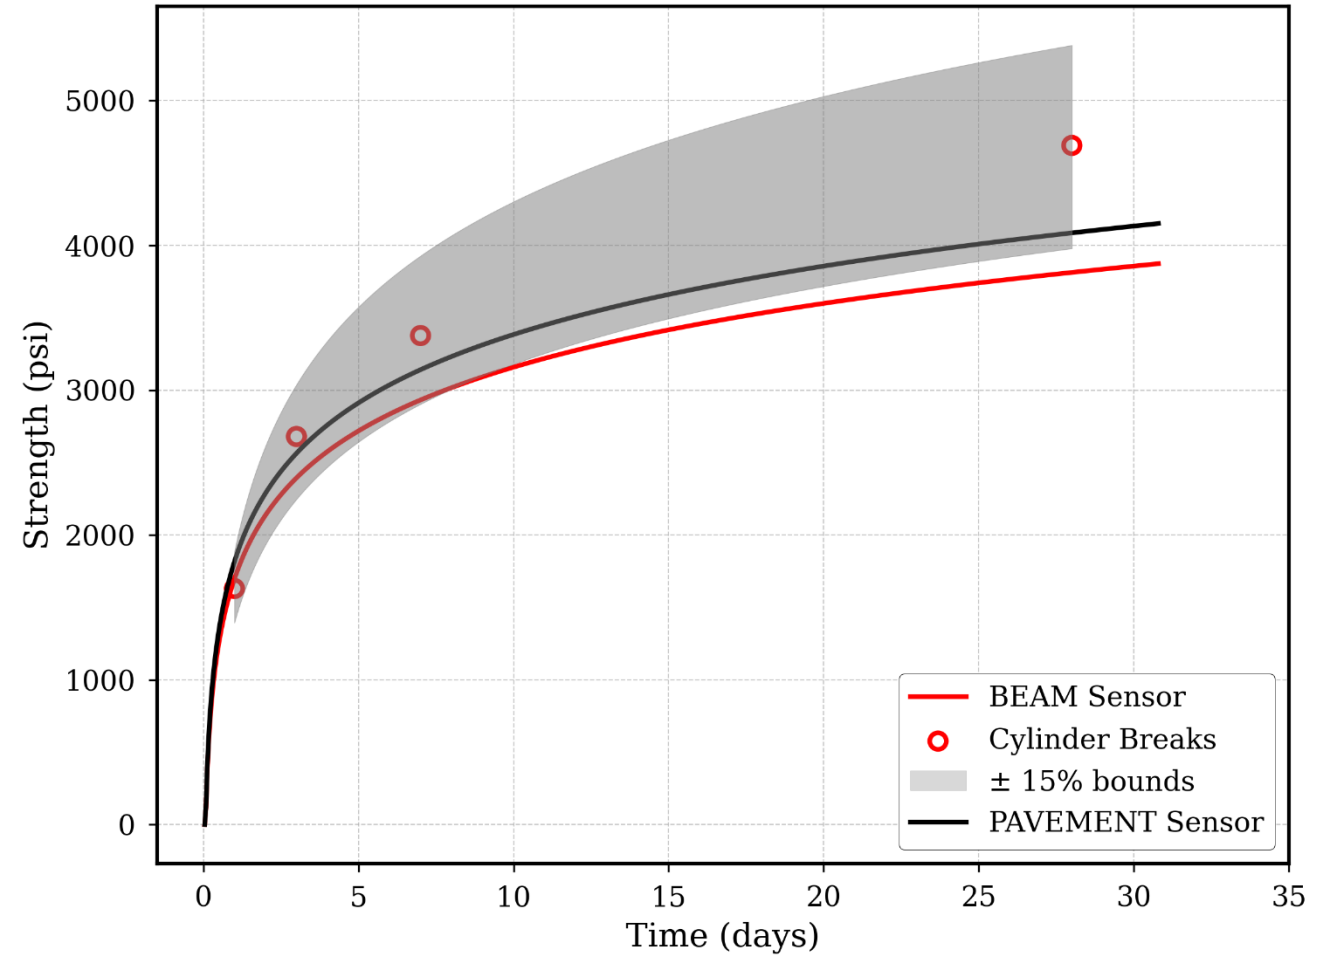
- Sensors were within 15% of cylinders at all ages except for 28-days, where it was within 16%
- Sensors were very consistent, with 3.4% variability in measurements across all ages

Age	Avg. Difference Cylinders vs Sensors (psi)	Avg. Difference Cylinders vs Sensors (%)
1-Day	125	7.6
3-Day	201	7.5
7-Day	340	10.0
28-Day	740	15.7

Age	Sensor Variability (%)
1-Day	3.4
3-Day	3.4
7-Day	3.4
28-Day	3.4

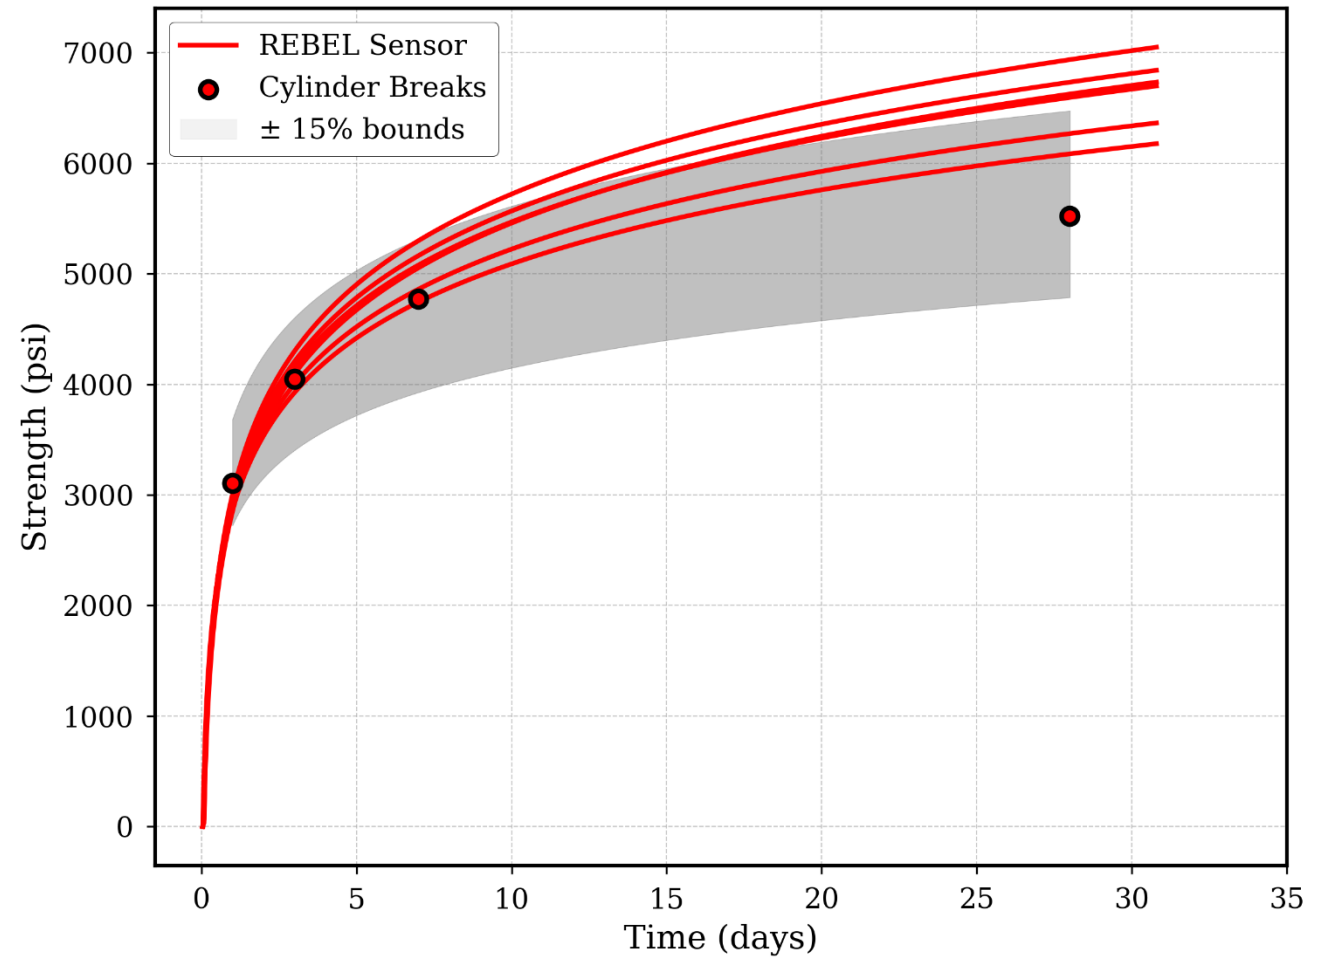
- Cylinder measurements were taken at 1-day, 3-day, 7-day, and 28-days
- Expected strength at 28-days was 4500 psi, so the sensor indicates the strength reached 4500 psi at about 5-day, which would have allowed earlier traffic opening.

Age	Avg. Difference Cylinders vs Sensors (psi)	Avg. Difference Cylinders vs Sensors (%)
1-Day	188	6.0
3-Day	112	2.7
7-Day	173	3.6
28-Day	1016	18.3

Age	Sensor Variability (%)
1-Day	1.9
3-Day	3.0
7-Day	3.7
28-Day	4.3

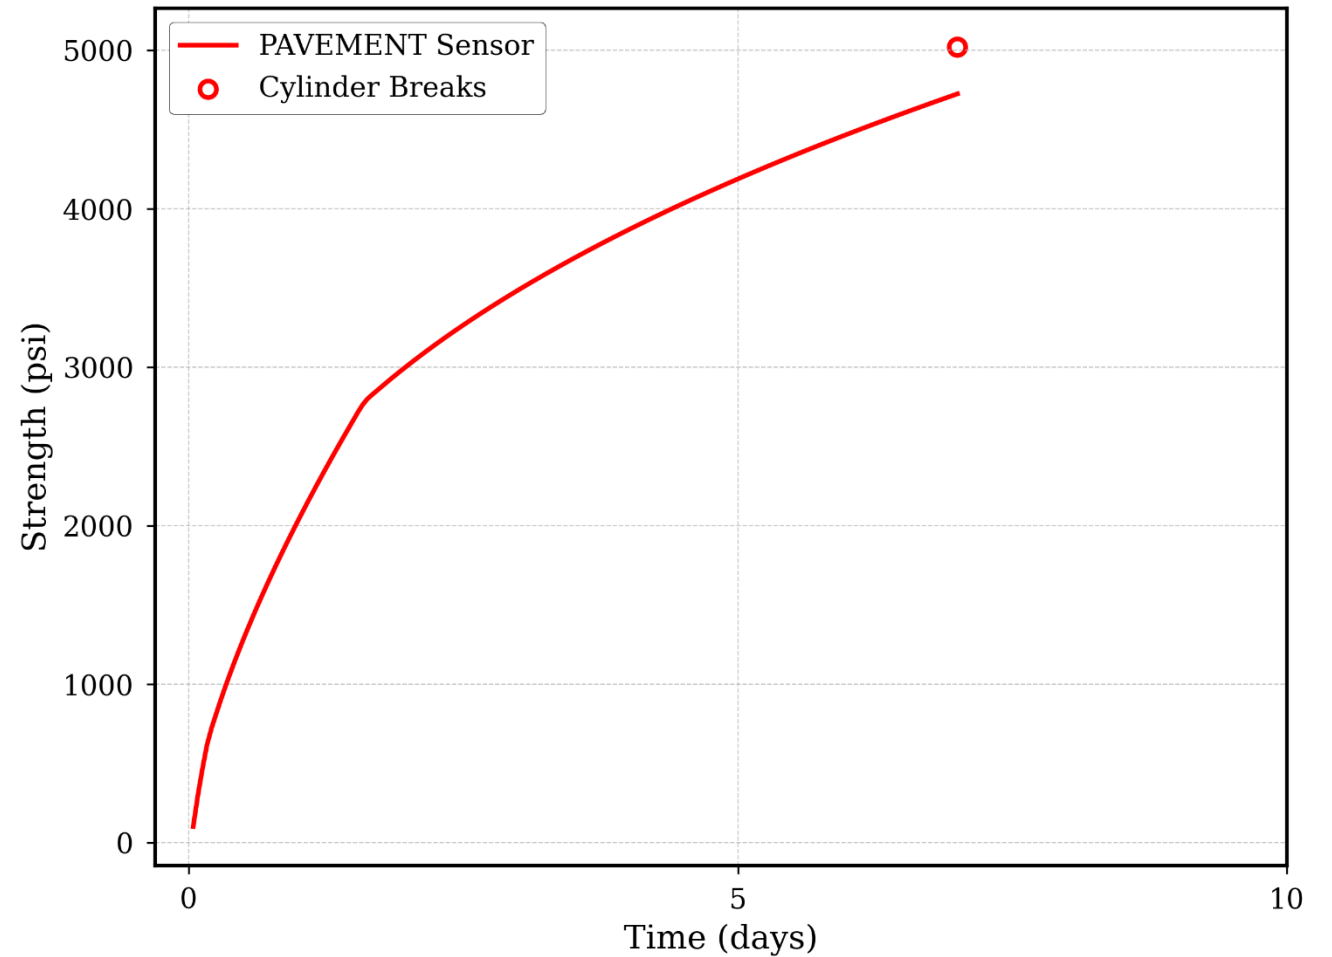
- Only one cylinder break was taken at 7-days
- One sensor was placed in the pavement for comparison
- Sensors were within 6% of cylinder break at 7-days

Age	Difference (psi)	Difference (%)
7-Day	294	5.8
